Old Palace Lodge Hotel, Dunstable: *Repair and restraint of the old clunch wall*

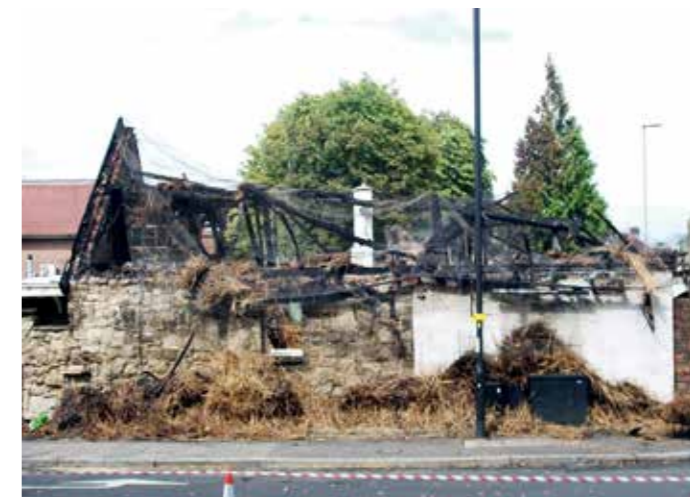
The Norman King Public House following the arson attack

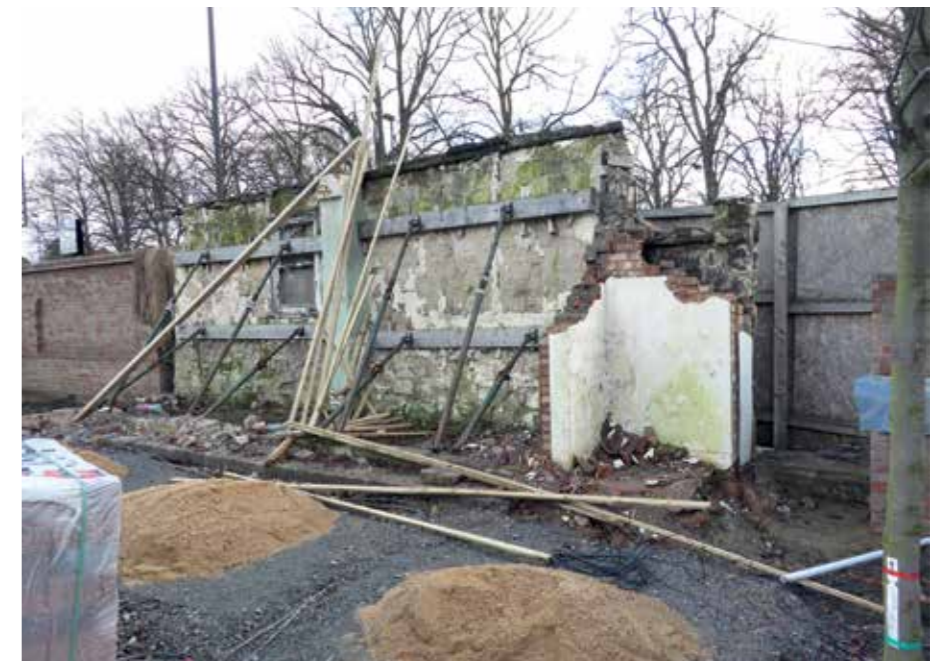
The clunch panel stood approximately 3.0m high and 8.4m long of which 1.2m at one end was of a poorer quality and lower height. The construction comprised two wythes of roughly coursed clunch stone and a rubble core amounting to an overall width of approximately 330mm. There was a window opening within the middle of the panel and the head of the wall was unrestrained following the loss of the roof in the fire. The wall was quite vertical and had been shored up before any significant lean could occur.

The clunch was very soft and the face of several stones had eroded, most significantly around small, localised areas of former repointing that had been undertaken in a cementitious mortar; typically, a much softer

lime mortar was still present throughout the panel.

The Clunch Wall Panel, temporarily supported and awaiting repair

The final solution comprised two masonry piers each side of the frame, each with a reinforced concrete core secured into a deep foundation pad. The foundation was local to the pier and thus did not undercut the clunch panel and could be dug without creating significant temporary stability issues.

The piers were to act as cantilevers, both to support a proportion of the wind load transferred directly to them through the panel and to resist the reaction from a horizontally spanning head beam that was also to be installed to restrain the head of the panel.

The head beam was to comprise an external brick envelope designed to emulate the new garden wall. Inside this façade of brick was introduced a reinforced concrete beam, designed to free span horizontally between piers. To create the necessary strength and stiffness, traditional cover depths to the reinforcement could not be achieved and a repair mortar (Renderoc HB 45 by Fosroc) was specified in place of a traditional RC35

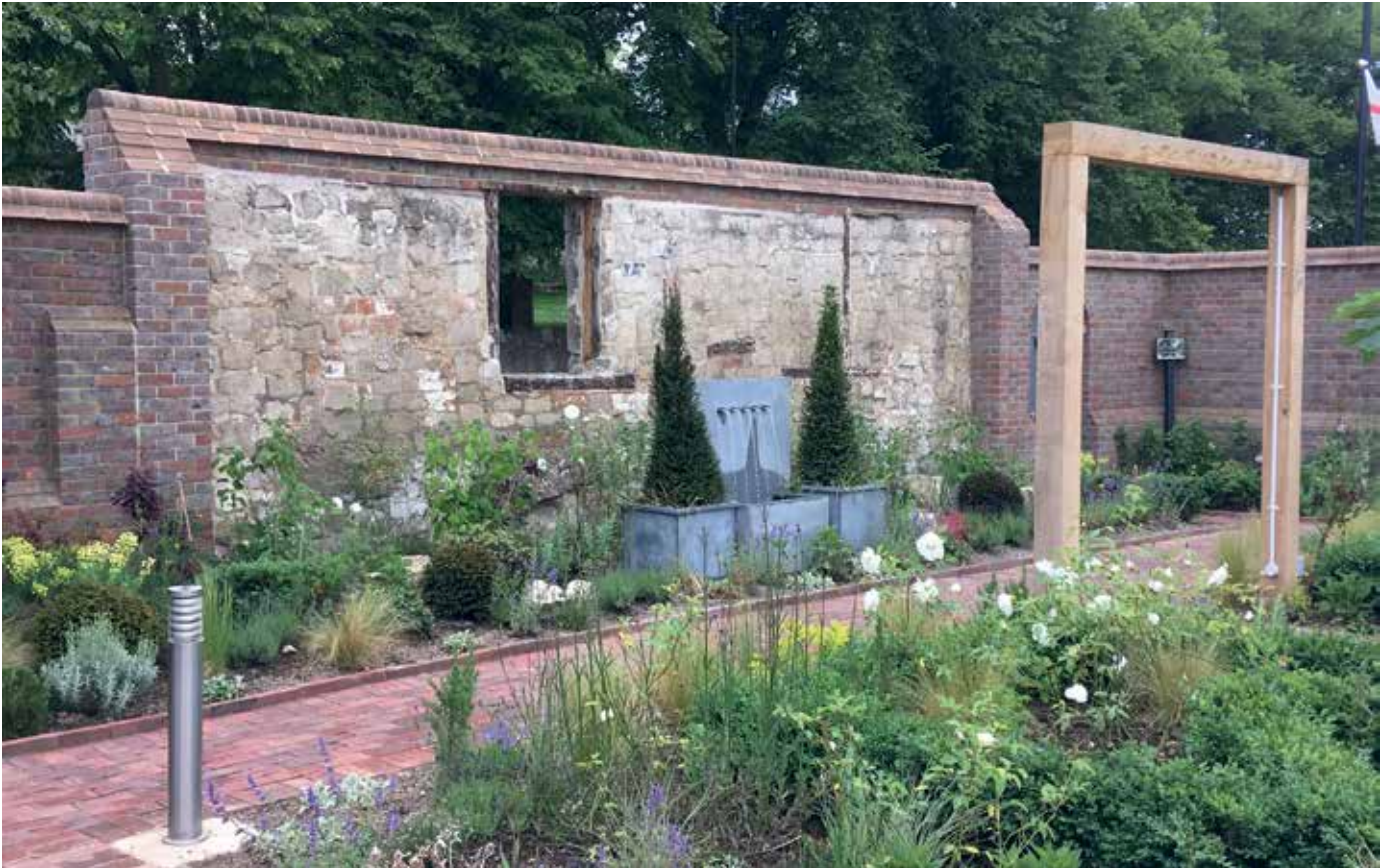
The finished wall viewed from the Tudor Garden of The Old Palace Lodge Hotel
