Selecting the right beam repair

This article will discuss the importance of understanding structural behaviour when making decisions about repairs. To demonstrate this it will consider variances in the scarf joints utilised in the repair of two different timbers of a 16th-century barn in Bedfordshire: the truss tie and purlin.

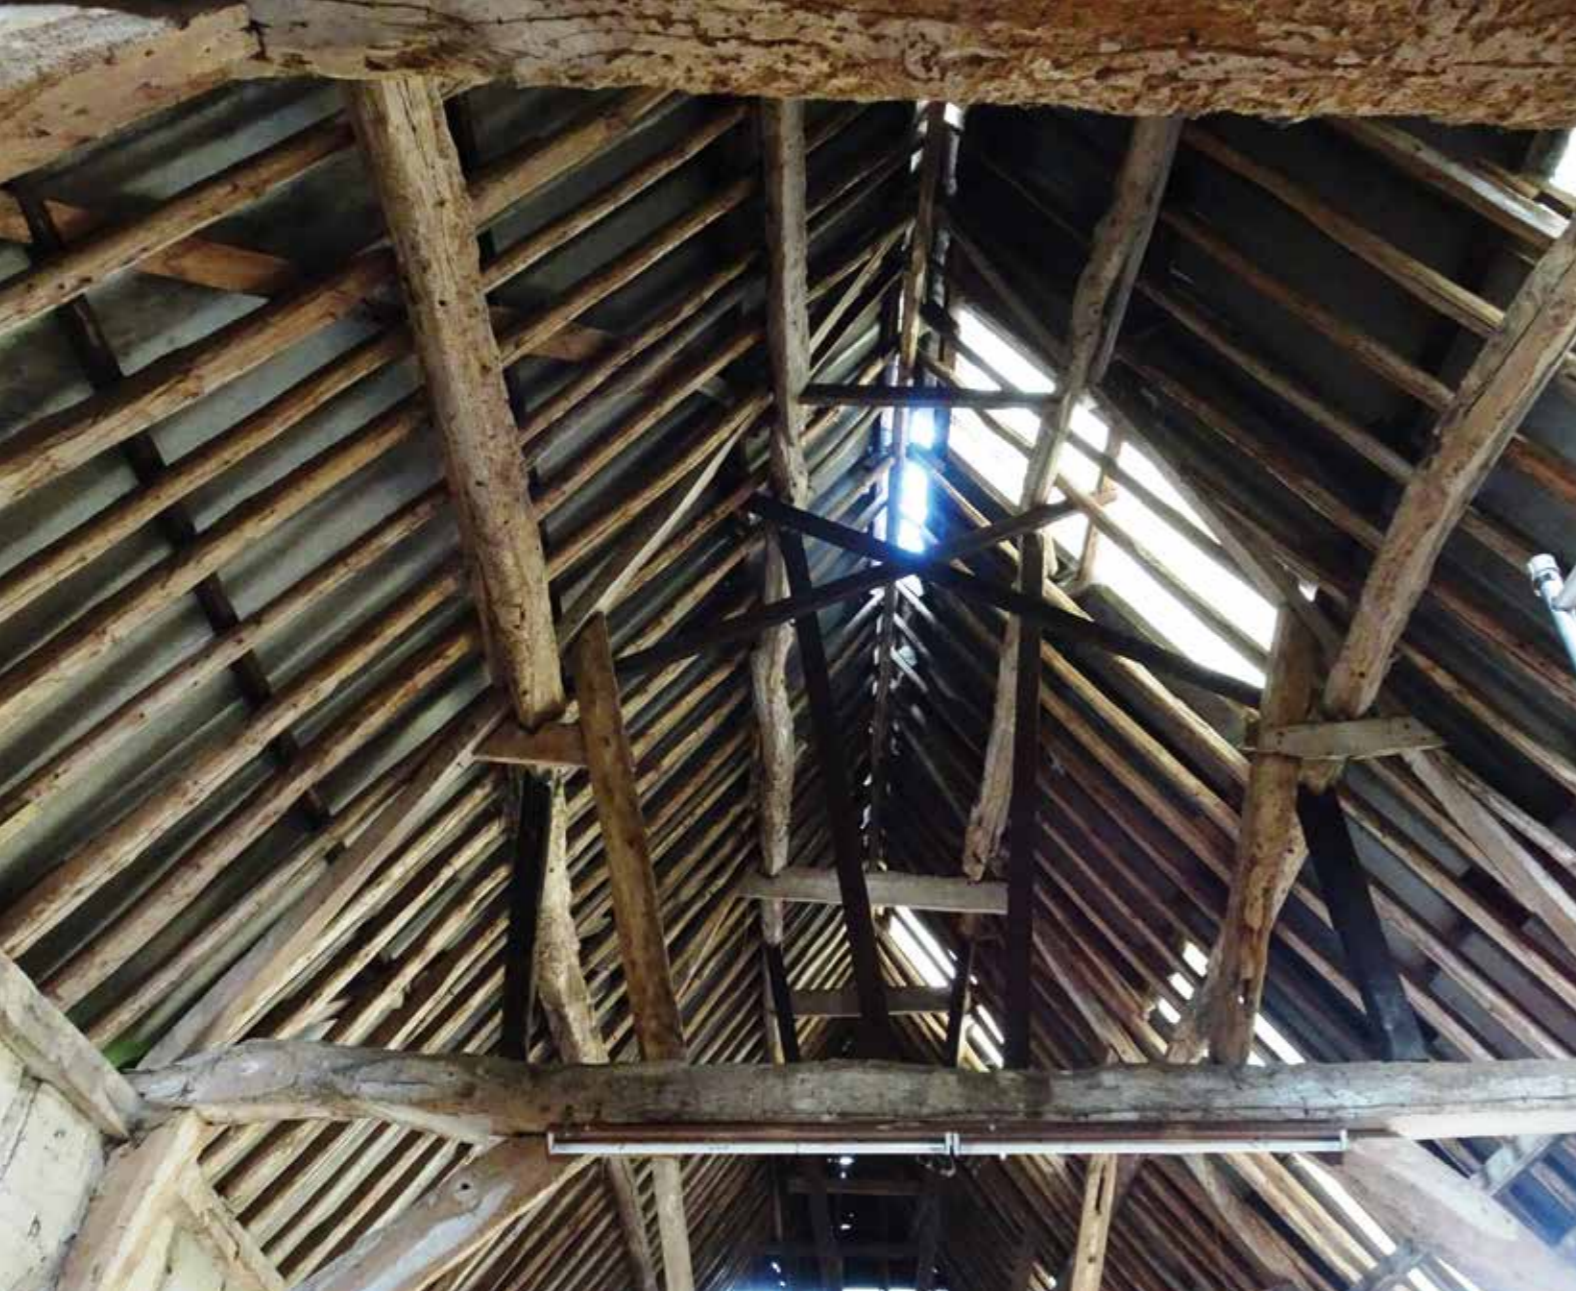
Shear and bending forces are less well understood. Shear forces relate to forces in opposite directions acting side by side, very much like the blades of scissors that slide across each other as they cut. Again, the greater the cross-sectional area of the material, the greater the shear force it can accommodate.

Bending is a complex mixture of tension, compression and shear forces acting together within a single beam.

When a beam is subjected to bending (in sagging), the upper fibres of the beam are forced together (compression); the lower fibres of the beam are pulled apart (tension). The distance between the compression and tension forces is what resists bending and, therefore, the deeper the section the greater the bending capacity of the beam.

With compression in the top of the beam and tension in the bottom, a horizontal shear develops in the beam between the forces acting in opposite directions. A vertical shear is also created at the supports where the weight on the beam is dragging it down and the support is holding the beam up.

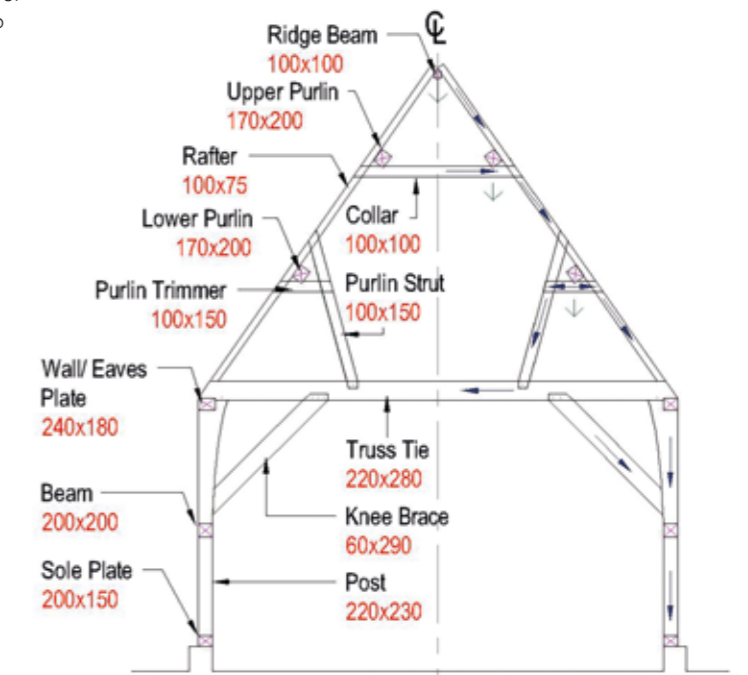
LOAD PATH DIAGRAM
Indicates the passage of load through the structure
Indicates the position and direction of load on the structure

In this diagram the cool colours (blues) indicate compression; warm colours (reds) indicate tension. It is clear from the diagram that there is significant tension in the tie beam.

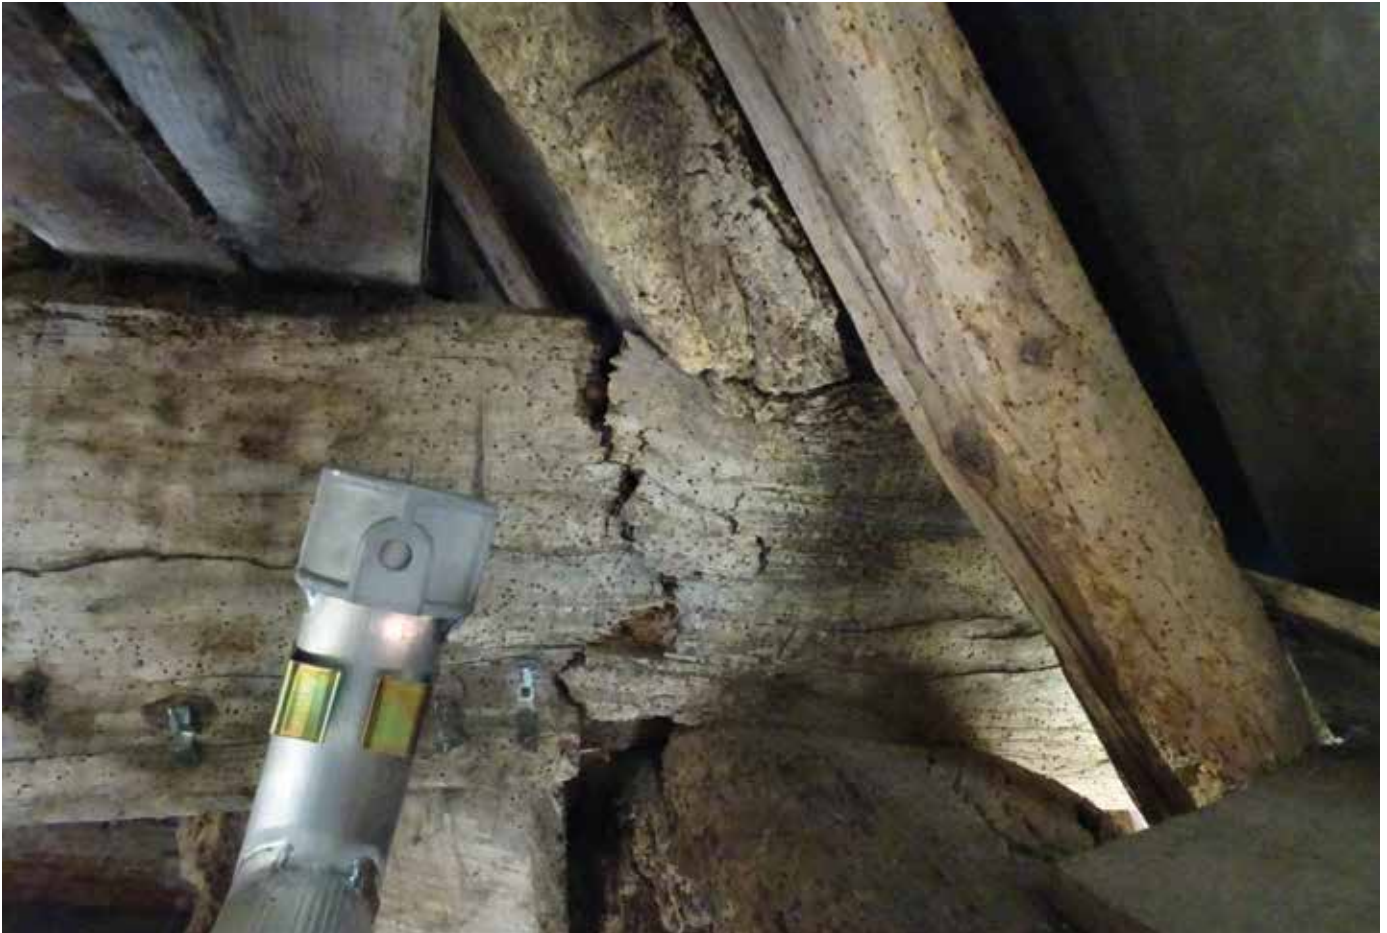
In the barn, the tie beam had cracked due to the weakening of the timber from beetle attack and the loss of wall plate, again through beetle attack, that meant the tie beam was unsupported directly below the rafter connection.

To repair the beam a new piece of wall plate was required, and the tie beam end required replacement.

A new piece of oak was proposed to replace the tie beam end, which needed jointing into the rest of the original tie beam being retained. A scarf joint with horizontal beds was adopted for this purpose.

This form of scarf joint is poor in resisting shear forces as the load prises the timbers apart along the line of the grain. The image above indicates the reduced section of timber that takes shear forces.

The joint is, however, strong in tension, which was the principal force in the tie beam. The tensile strength derives from the length of timber resisting tension forces, which is also displayed on the image to the right.

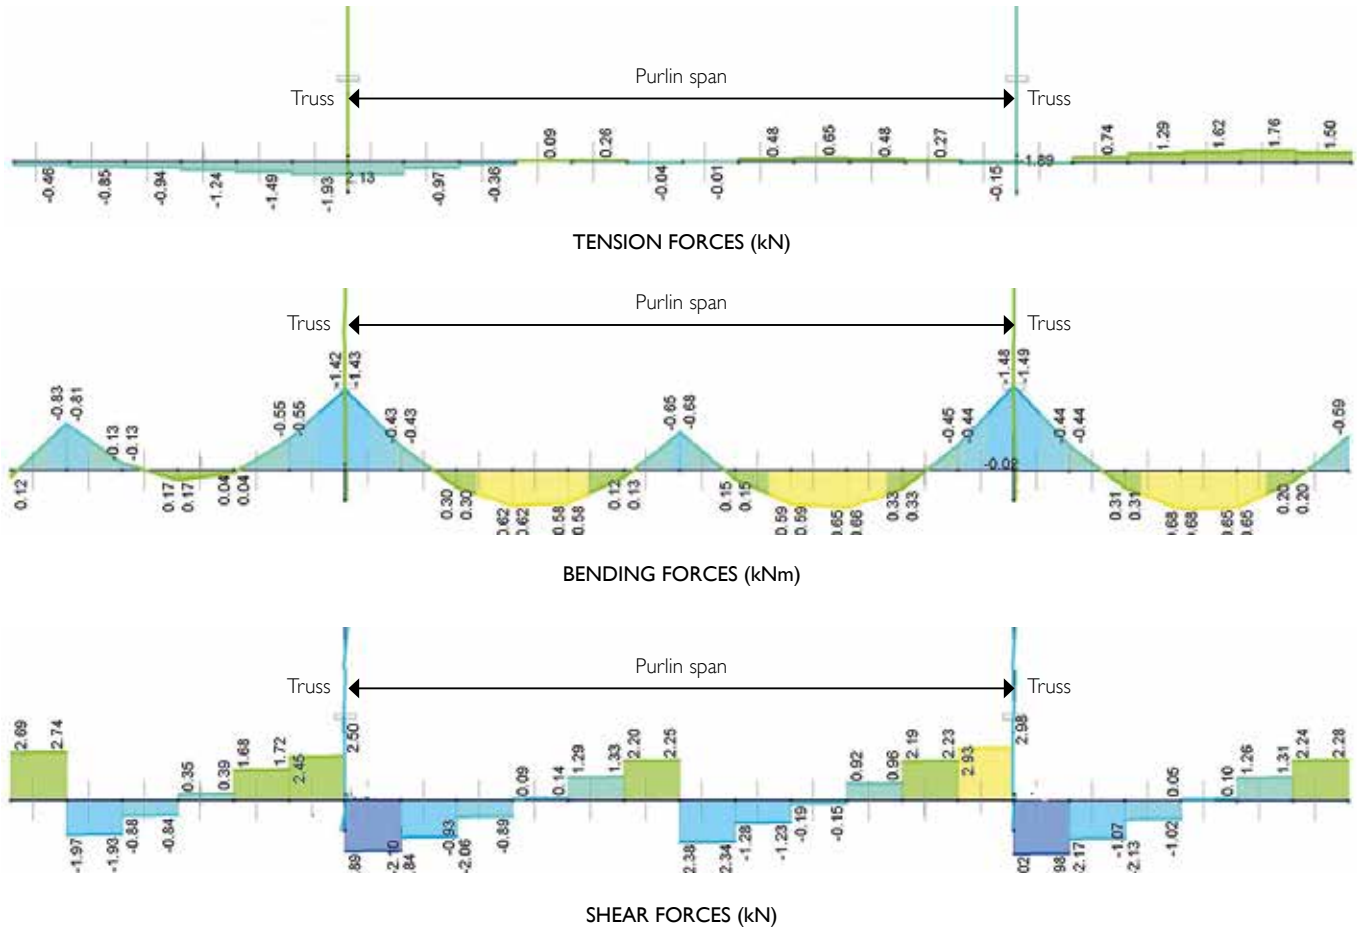
This scarf joint was used to repair the tie beam since the repair was required to take relatively large tensile forces and relatively small shear forces.

The purlins were subjected to bending and shear forces principally and had little pure tension or compression forces acting upon them. The diagrams above show the typical forces expected in the purlins.
